# LAMPS meeting 20200515

# Neutron detector waveform analysis

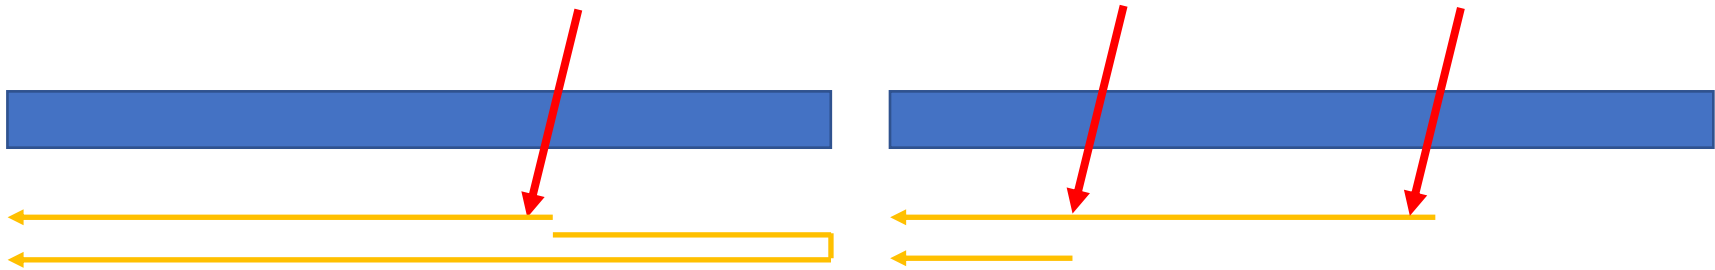
- To solve reflected light effect & multi-hit event
- Basic waveform function
  - $h_1 \times \operatorname{erf}\left(\frac{x-t_1}{\sigma_1}\right) \exp\left(\frac{x-t_1}{\sigma_2}\right)$
  - H1 : height
  - T1 : timing
  - Sigma 1 : Raising slope
  - Sigma 2 : Falling slope
- Fitting signal waveform with combination of two or three basic waveform considering delay and attenuation.

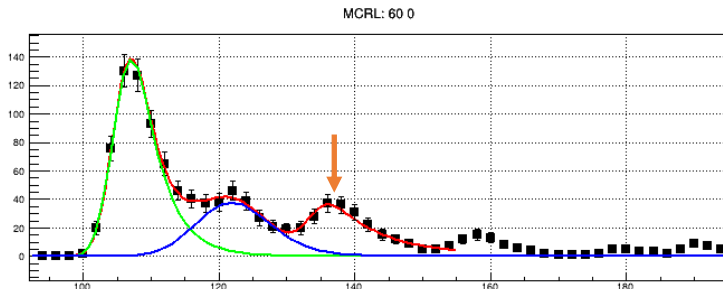
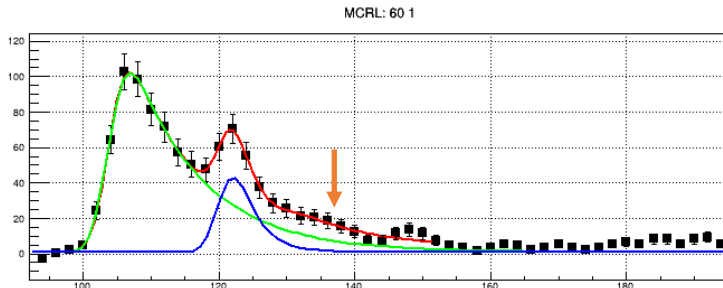
## Multi-hit candidate

- Several multi-hit candidate events were found. An Example shows additional signal after 30 ns.
- Multi-hit MC test will be done for Au+Au collision.
